# Bonsall

Conservation Area Appraisal

## 8. Negative/Neutral Factors

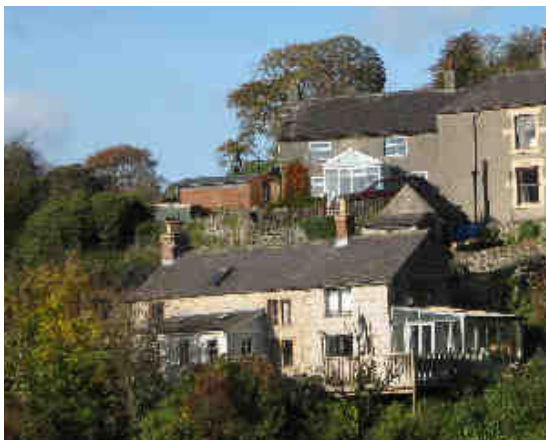
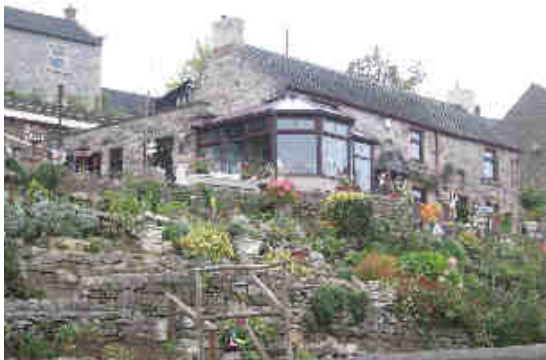
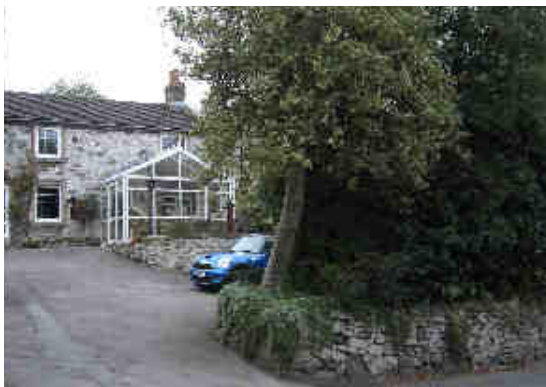
Extensions to buildings should respect the host building to which the extension is to be affixed. In this regard considerations include size, scale, form, mass, materials and details such as windows and door designs. The form and design of an extension should also be considered in respect of its location on the principal building. There are several instances in Bonsall where large glazed porches / conservatories have been attached to the principal elevation of a property. This type of structure has no historical precedent for use on traditional properties in the village.

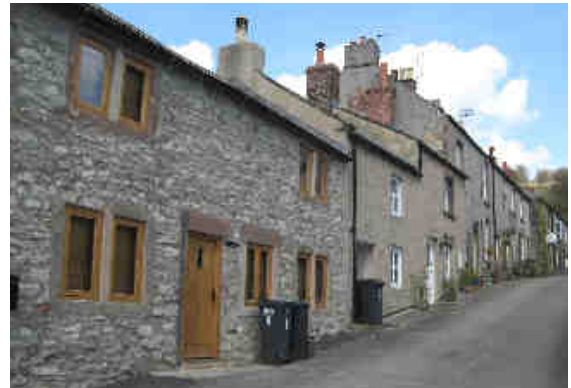
Changes to traditional window and door patterns both in terms of their construction materials and design can have a significant cumulative impact on the external appearance of historic cottages and houses. Traditional windows would have been timber with a painted (not stained) finish. There are instances throughout the village of plastic windows and doors, many of unsympathetic design and examples of staining used for windows and doors.

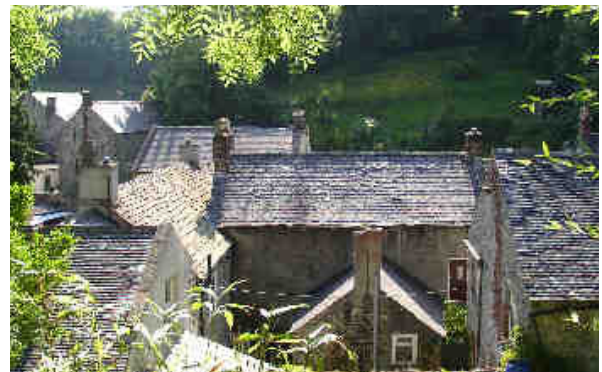
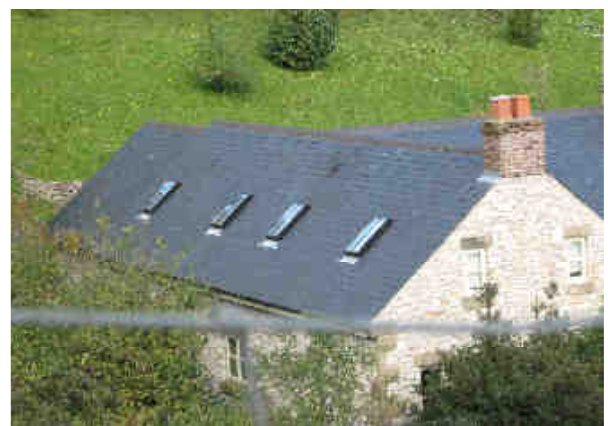
A positive characteristic of the village, is that there are very few roof-lights to interrupt roof planes. The topography of the village provides a multitude of views, panoramic and long ranging as well as more contained views within the village itself. As such roofscapes are often in full view. Features such as modern dormers and roof-lights interfere with the traditional character of the village.

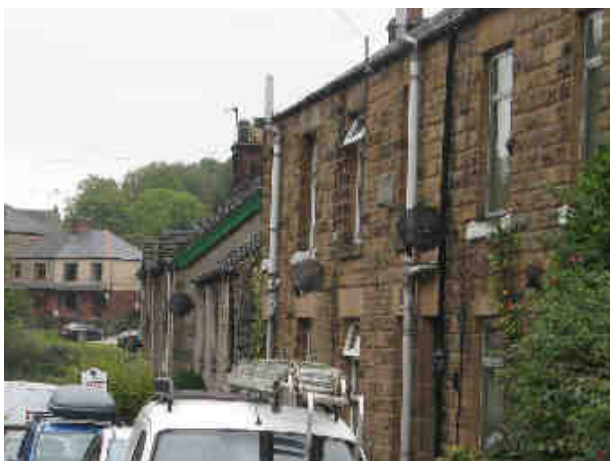
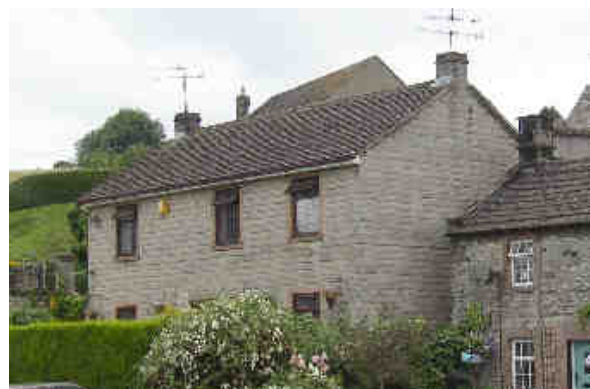
Numerous minor additions to buildings, lead to a visual conglomeration and cumulatively can detract from the building and the wider street-scene. Whilst it is recognised that improved television reception is desired, satellite dishes positioned on front elevations, especially on principal road frontages lead to visual clutter in the street-scene. Often a more discrete location can be found.

*Artificial building materials on late 20<sup>th</sup> century property*

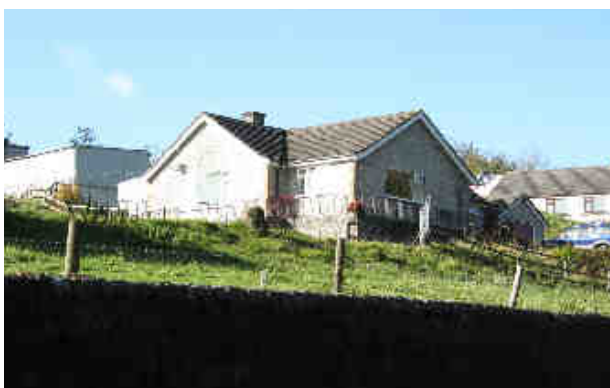
In general the majority of the properties in the village are constructed to a traditional design and use natural materials. These elements help to provide a holistic character to the village. However, there are a few examples of house types, e.g. bungalows, which are not a characteristic building form.

*20<sup>th</sup> century bungalows are not representative of traditional building designs.*

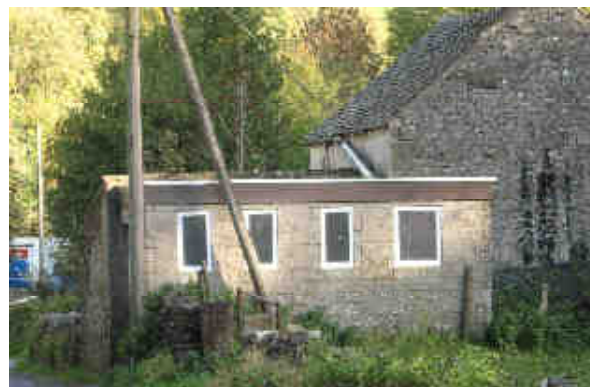
Similarly, there are a number of properties which have been built in artificial materials (e.g. Davy block, artificial stone, concrete tiles) and where structures have few design elements (i.e. flat roof, utilitarian design details) to identify them as being a part of the special character and appearance of the Conservation Area.

*Flat roofed toilet block*

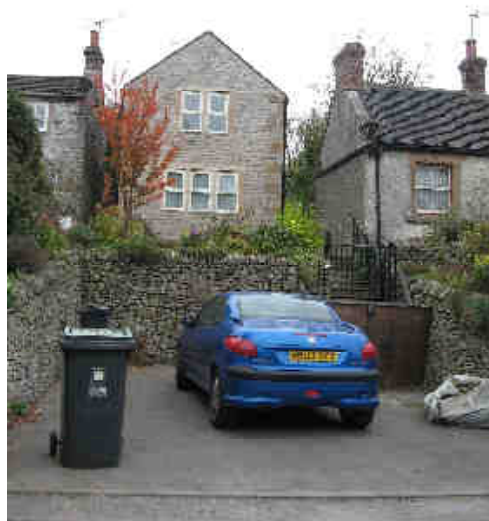
Limestone walls, generally random rubble construction with a variety of coping details, are a highly characteristic feature throughout the Conservation Area. Whether performing a function as retaining walls or in a more visual capacity, forming a field or garden boundary they provide a sense of enclosure as well as being distinctive features in the streetscape/landscape. In the more developed areas of the village, they create a defined edge to the roadways. Whilst car parking is an issue on the narrow lanes and streets, the removal of these walls for off-road parking creates 'breaks' in that sense of enclosure and weakens the definition of the street-scene.

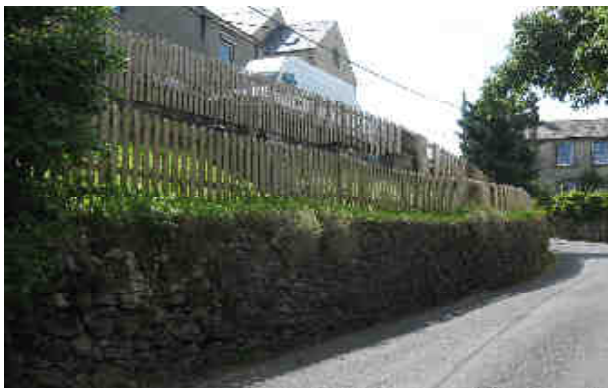
The use of inappropriate boundary treatments also weakens the robust character provided by walls within the area.

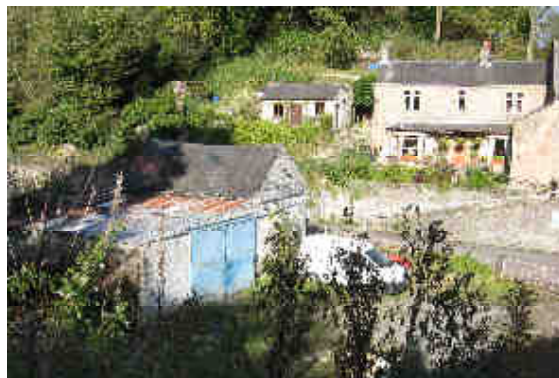
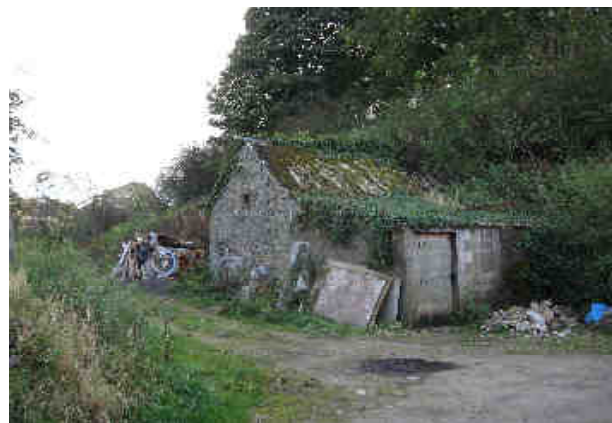
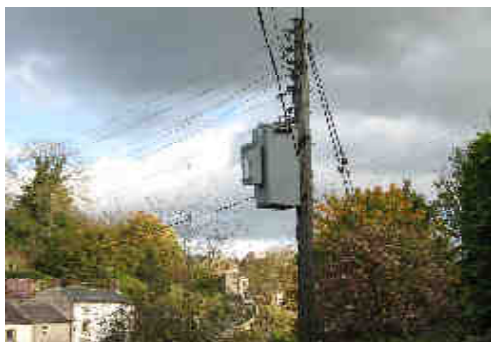
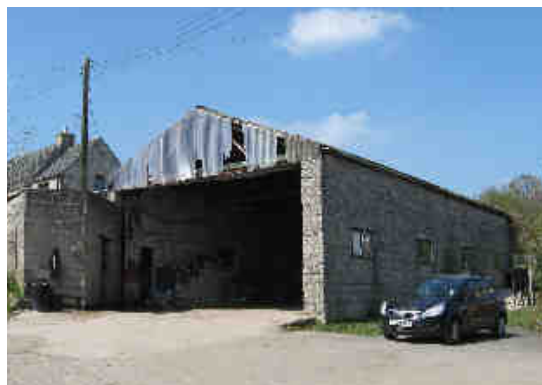
There are numerous features in the Conservation Area that add to the distinctive nature of the area, such as wells, post boxes, telephone kiosks, railings, gate piers and stiles. However there are certain elements that are considered to detract from the overall street-scene. These are not found extensively within the Conservation Area, but include examples of overhead cables, untidy sites and derelict / poorly maintained commercial buildings.

*Above & below -Poorly maintained commercial buildings*

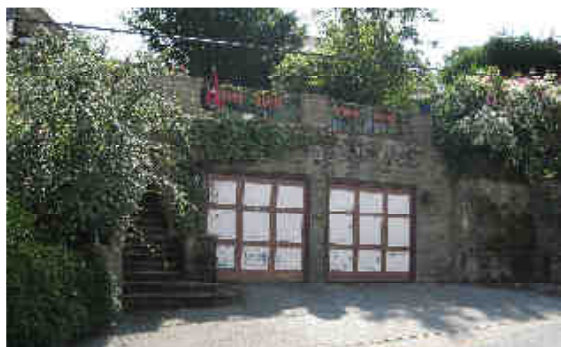
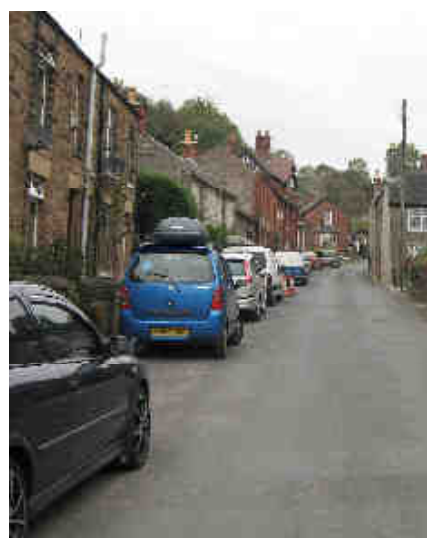
Examples of modern garaging, could be improved by the use of a more traditional design of doors painted a dark recessive colour. Car parking does not enhance the street-scene being visually intrusive and in places where there are no footways, makes pedestrian movement through the village more difficult.

*Car parking along Yeoman Street*

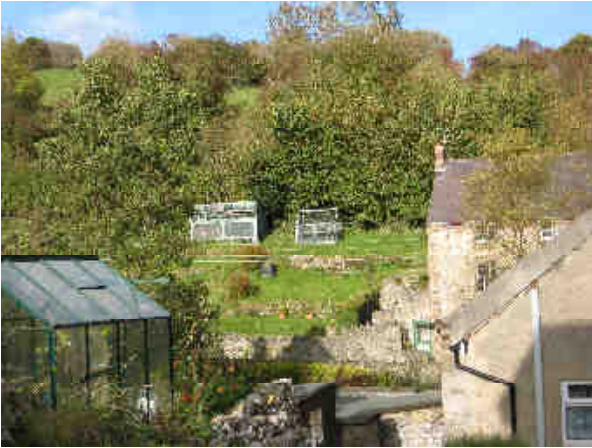
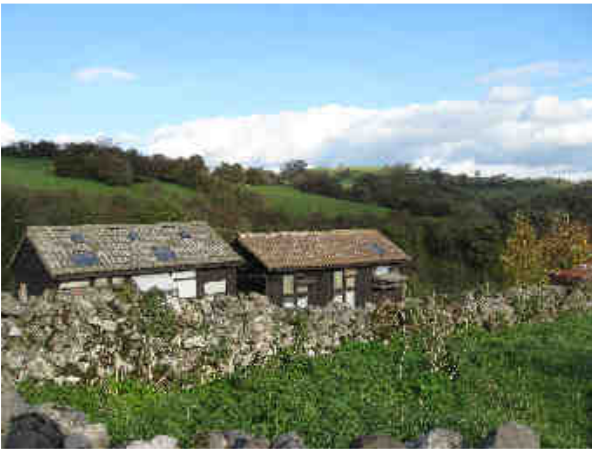
The Village has a number of outbuildings including pigeon lofts. Despite the majority of these being located in private gardens, many are visible in the landscape / streetscape due to the topography of the area.

The Village Design Statement (2002) identified a number of residents with lofts on their land and the Village Design Statement considers that the pigeon lofts contribute to Bonsall's sense of place and add to the distinctive character of the village.

These structures are characteristic to Bonsall and are considered neither to detract nor enhance the area, but demonstrate associated activities of an active working community.
