Bonsall

Conservation Area Appraisal

9. General Condition

- Problems, Pressures & Capacity for Change

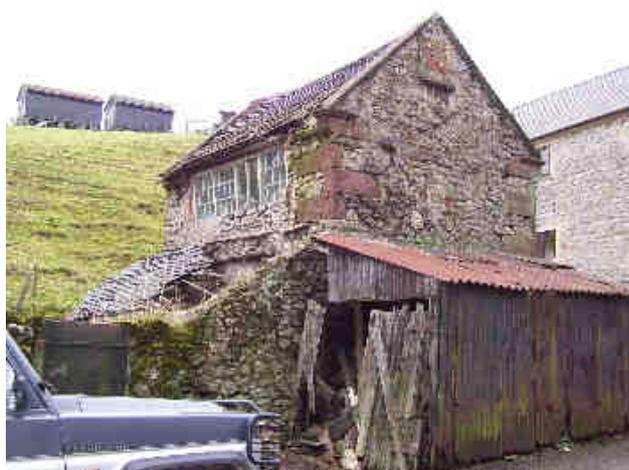
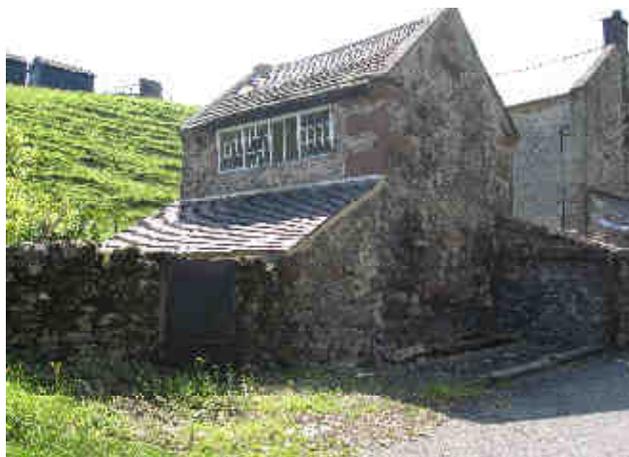
Framework Knitters Workshop The Dale

Historic buildings in the area, both listed and un-listed are also generally in good condition. The exceptions to this in the past have been the Framework Knitters Workshops, both the listed workshop adjacent to Yew Tree Farm and the unlisted workshop to the rear of No 4 High Street. More recently both these buildings have had repair works undertaken to make them wind and weatherproof and which have resulted in preserving their character. The Bonsall Framework Knitters Group, the Bonsall Field Barn Project, the owners and the District Council, have worked together and managed to retain these historic buildings for future posterity.

Before

After

The Workshops are a unique feature of Bonsall's existing character and appearance as well as a record and depiction of the social history of the village and the industries they represented. Buildings which cannot easily be utilized for a viable end-use are more likely to become a burden for the owner and small buildings such as these, are difficult to find an end-use which can protect their long-term future. The loss of these buildings to the special character and appearance of the village, would be significant and it is important that these buildings are still considered as 'vulnerable' despite the recent efforts to preserve and protect them.

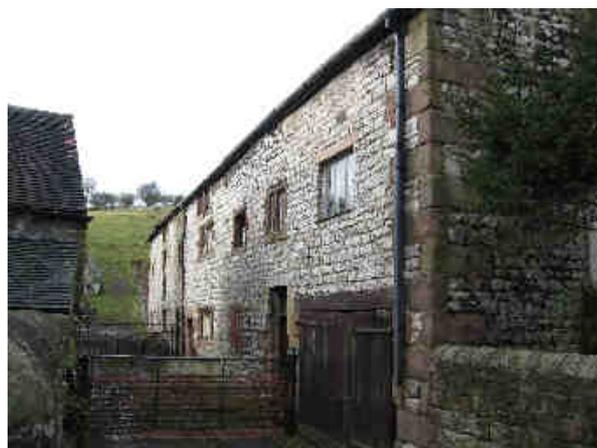
No. 1 High Street

None of the historic buildings in the village have been formally designated as 'at risk' although the District Council has been made aware of the current situation regarding No. 1 High Street. This building is currently being monitored by the District Council and it will be added to the local 'Heritage at Risk' Register in 2011 if a scheme has not been brought forward for its repair / re-use.

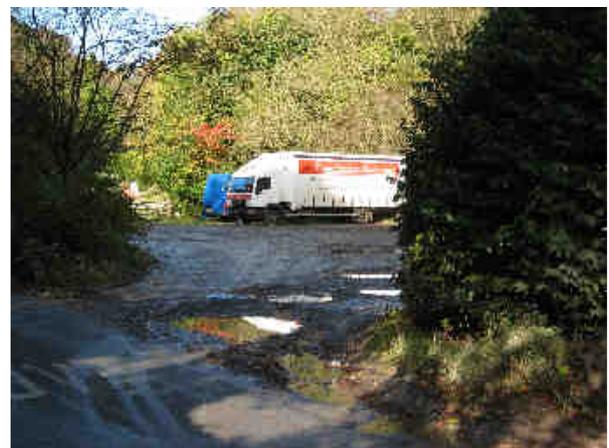
Lorry park on Clatterway

As mentioned in 'Negative Factors' some commercial buildings and associated land would benefit from improvements. The lorry park on Clatterway, whilst relatively well-screened from a number of public vantage points, nevertheless utilises an open piece of land for a relatively intensive use. As such the area shows signs of 'wear and tear' with resulting uneven surfacing. Large vehicles using both the access carriageway and parking area have an impact on the character and appearance of the Conservation Area.
